1 Specimens

2 Relevant Specification

3 Test procedure

4 Results

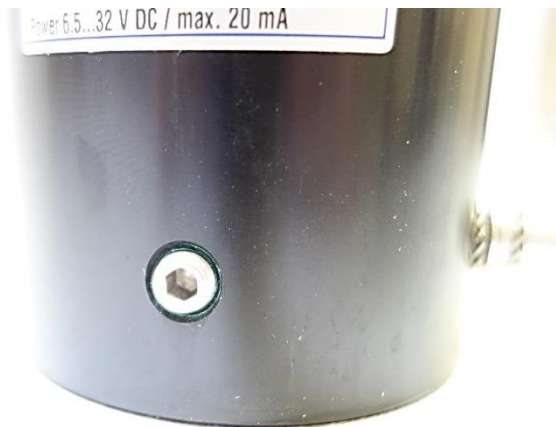
fig. 21

Specimen no. 50-18-0403-2
after the condensation test

Verdigris between housing and a screw

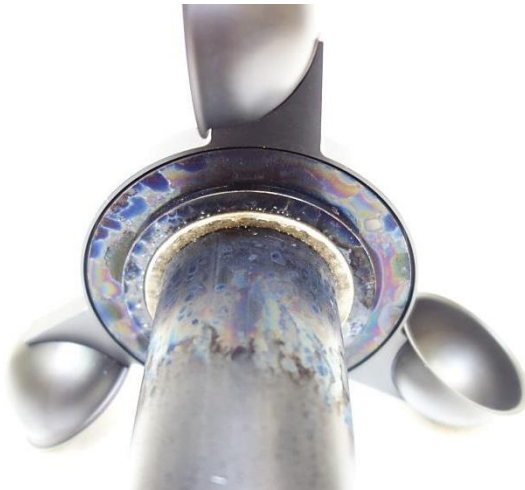
fig. 33

Specimen no. 50-18-0403-6
after the condensation test

Stains on the surface and surface defects
in the black anodized layer

Swollen seal between housing and cup
rotor

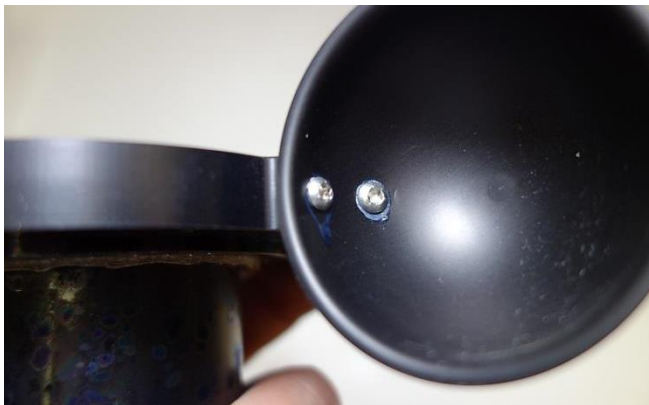
fig. 34

Specimen no. 50-18-0403-6
after the condensation test

White corrosion products around the cup
screws

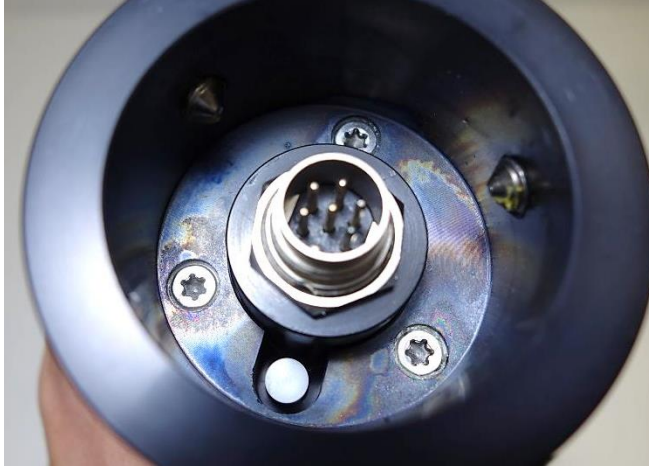
fig. 35

Specimen no. 50-18-0403-6
after the condensation test

Stains on the surface and surface defects
at the black anodized layer (bottom)

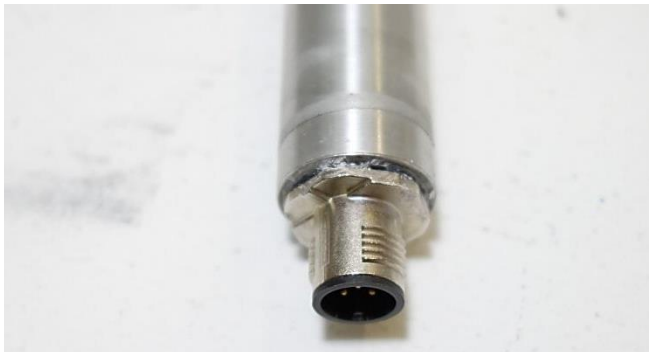
fig. 39

Specimen no. 50-18-0403-8a
after the condensation test

White corrosion products around the
connector

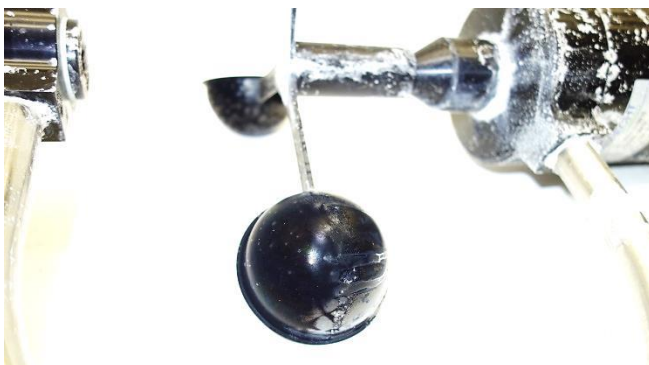
fig. 47

Specimen no. 50-18-0403-2
after the salt mist test

Stains on the surfaces and surface
defects at the black anodized layer (rotor
cup)

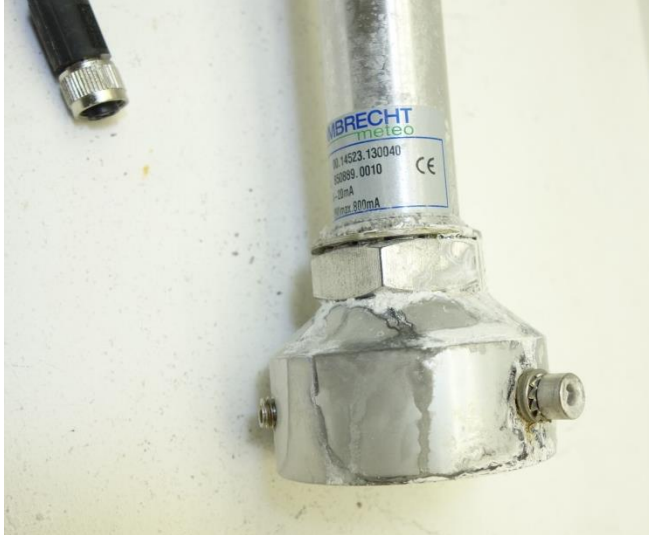
fig. 54

Specimen no. 50-18-0403-4
after the salt mist test

Signs of corrosion of the housing
White and grey deposits between nut and
sensor housing (no evaluation of the foot)

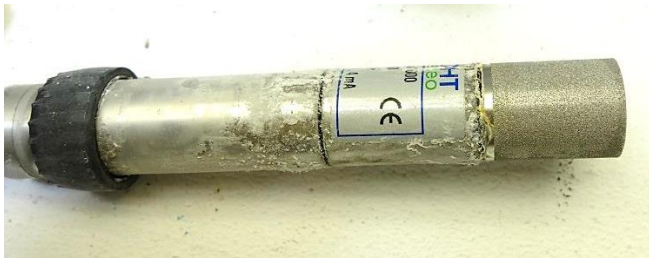
fig. 68

Specimen no. 50-18-0403-8a
after the salt mist test

White deposits and corrosion traces at the
sensor

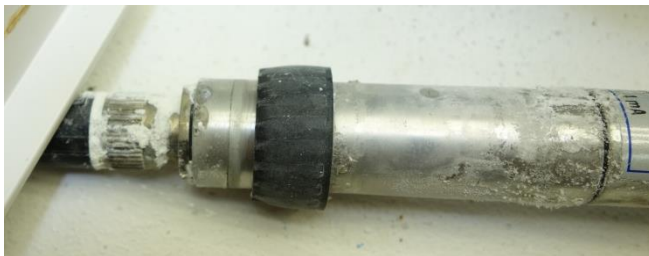
fig. 69

Specimen no. 50-18-0403-8a removed
from Specimen no. 50-18-0403-8b
after the salt mist test

White deposits at the surface
plug not removable (normal force)

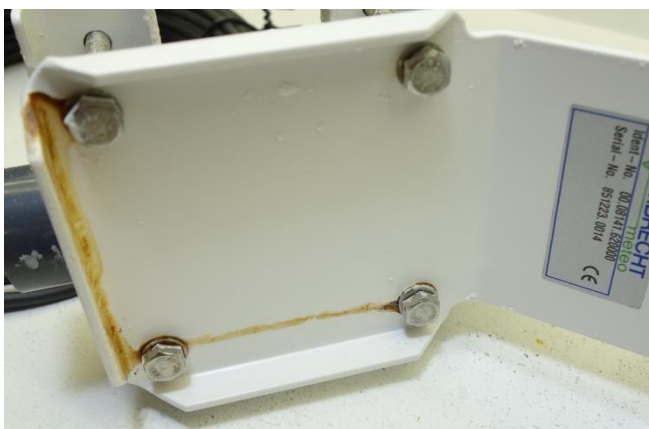
fig. 70

Specimen no. 50-18-0403-8b
after the salt mist test

Red rust under the connection screws
(coating defects)
