1 **Specimens**

2 Relevant Specification

3 Test procedure

4 Results

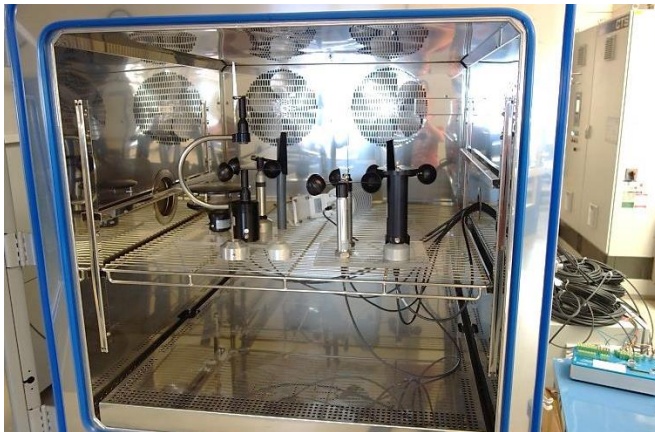
fig. 9

test setup:
specimens in the climate test chamber
(cold test)

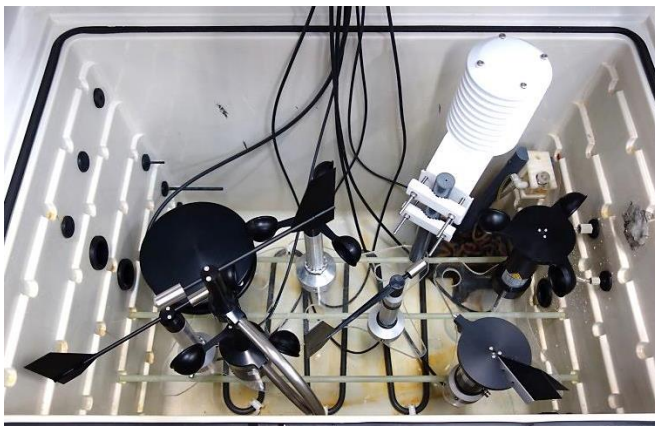
fig. 10

test setup:
specimens in the salt mist test chamber
(condensation test)

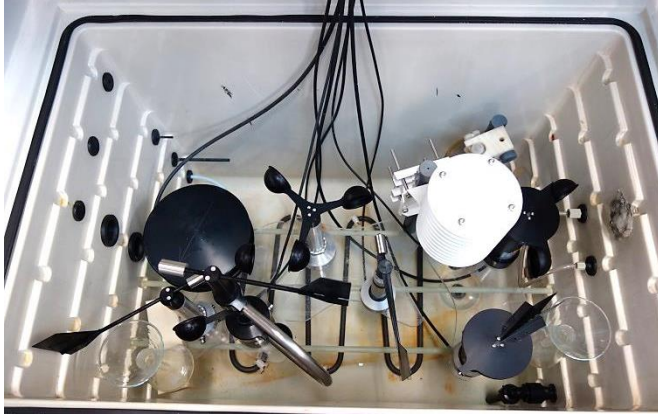
fig. 11

test setup:
specimens in the salt mist test chamber
(salt mist test)

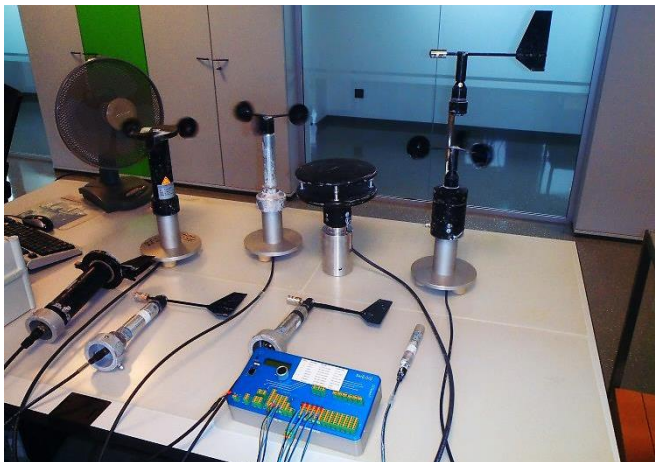
fig. 12

Specimen no. 50-18-0403-1..-8(a/b)
test setup after all exposures

operability test, carried out by the
customer

Channel no.	without airflow	with airflow
1	23 16470 WG 0,0 m/s	23 16470 WG 2,5 m/s
2	30 14581 WG 0,0 m/s	30 14581 WG 1,8 m/s
3	34 08095 TA 22,4 Grad C	34 08095 TA 22,2 Grad C
4	03 14524 WG 0,0 m/s	03 14524 WG 2,1 m/s
5	04 14523 WR 140,0 Grad	04 14523 WR 140,0 Grad
6	05 14567 WR 342,1 Grad	05 14567 WR 342,1 Grad
7	06 14602 WG 0,0 m/s	06 14602 WG 1,6 m/s
8	07 14601 WR 24,9 Grad	07 14601 WR 24,6 Grad

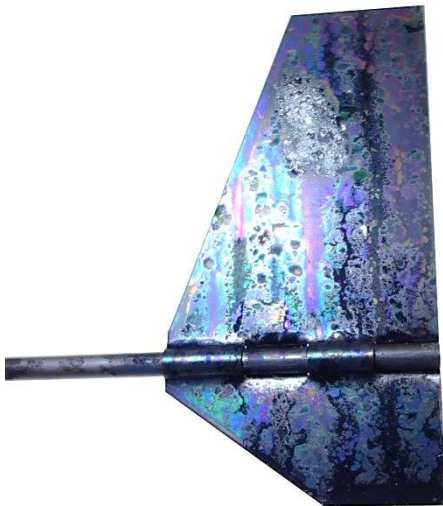
fig. 18

Specimen no. 50-18-0403-2
after the condensation test

Detailed: wind direction vane;
surface defects at the black anodized
layer

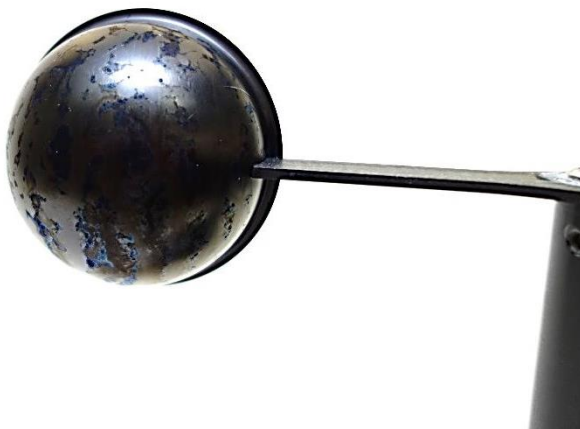
fig. 19

Specimen no. 50-18-0403-2
after the condensation test

Surface defects at the black anodized
layer (rotor cups)

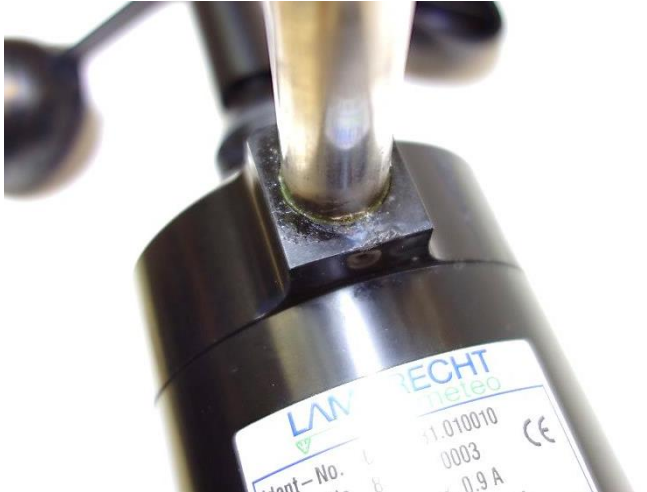
fig. 20

Specimen no. 50-18-0403-2
after the condensation test

Verdigris between housing and bow
connection

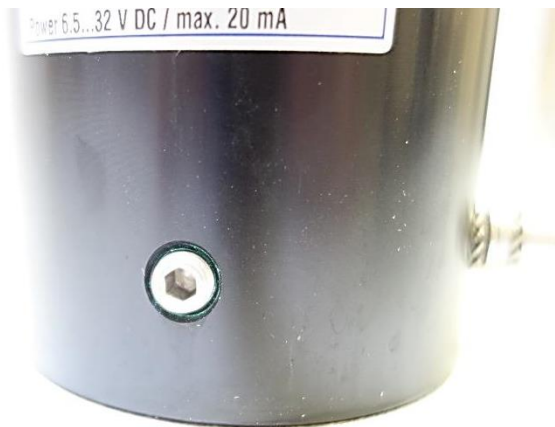
fig. 21

Specimen no. 50-18-0403-2
after the condensation test

Verdigris between housing and a screw

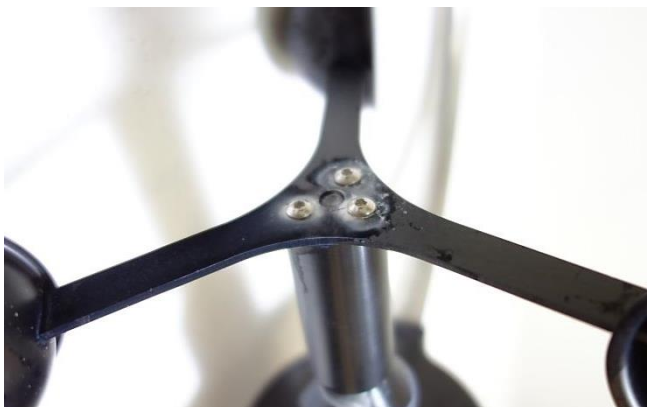
fig. 22

Specimen no. 50-18-0403-2
after the condensation test

White corrosion products around the cup
rotor screws

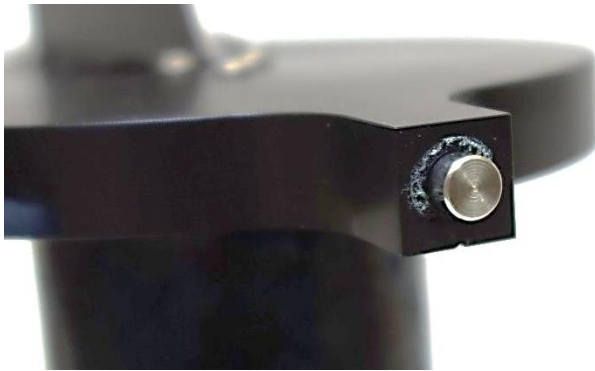
fig. 30

Specimen no. 50-18-0403-5
after the condensation test

White corrosion products around the
screw

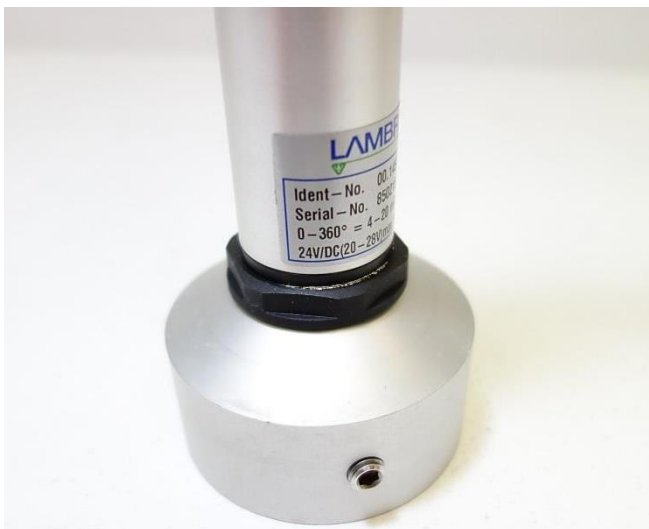
fig. 37

Specimen no. 50-18-0403-7
after the condensation test

White deposits at the nut

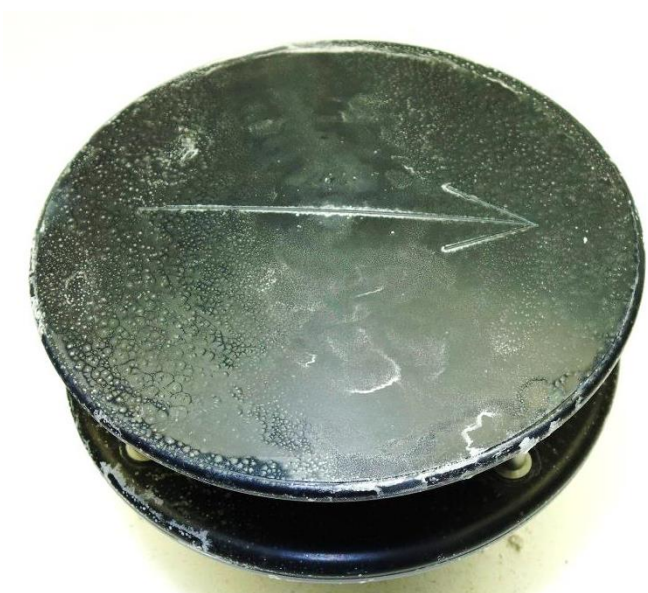
fig. 43

Specimen no. 50-18-0403-1
after the salt mist test

Stains on the surfaces and surface
defects at the black anodized layer

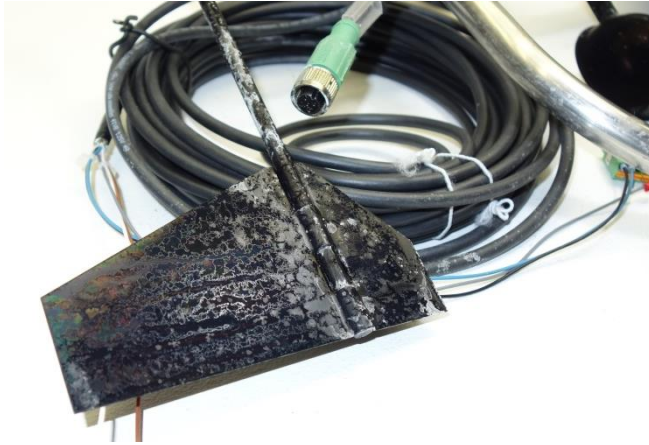
fig. 45

Specimen no. 50-18-0403-2
after the salt mist test

Stains on the surfaces and surface
defects at the black anodized layer

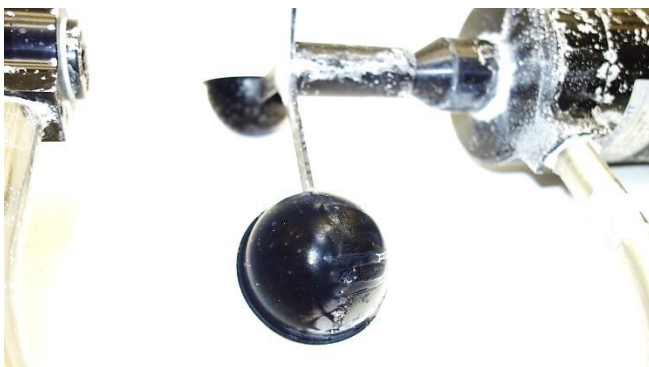
fig. 47

Specimen no. 50-18-0403-2
after the salt mist test

Stains on the surfaces and surface
defects at the black anodized layer (rotor
cup)

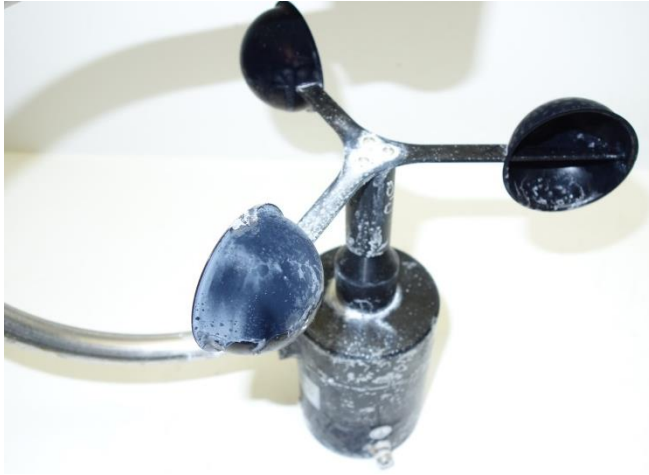
fig. 48

Specimen no. 50-18-0403-2
after the salt mist test

Stains on the surfaces and surface
defects at the black anodized layer

White deposits on the cup rotor and cup

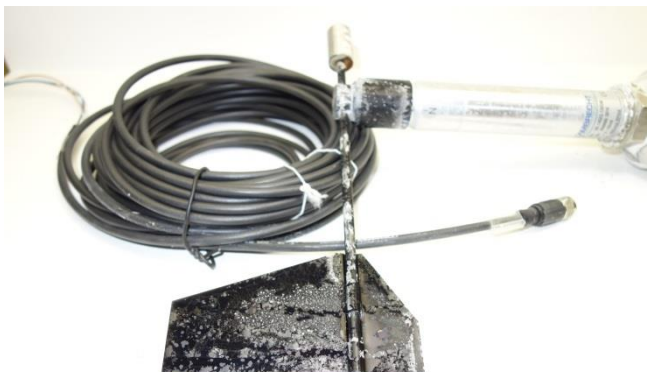
fig. 53

Specimen no. 50-18-0403-4
after the salt mist test

Stains on the surfaces and surface
defects at the black anodized layer
